3. SeaSoar

3.1 Penguin

3.1.1 Introduction

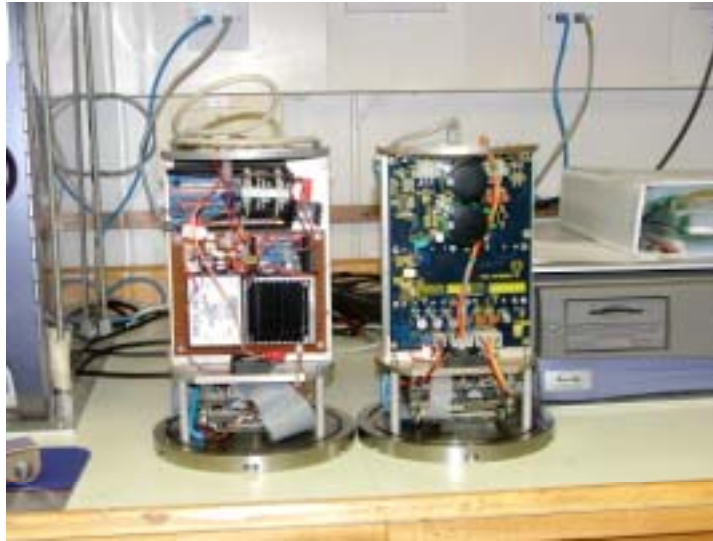
Fig. 3.1 Prototype (left) and production (right) Penguin units

The underwater units previously used on UKORS supported cruises were prototypes, with two veroboard circuit boards (one for the power supply, and one for the interface board). Prior to this cruise, Seamap were contracted to develop the prototype Penguin system into a more supportable “production” system. Improvements to the system included:

- Improved robustness of power supply design
- Fuses on the sea power input
- Fuses on the low power +/-15V and 5V outputs
- Provision for control over individual instrument power
- Provision for voltage monitoring of the low voltage supplies
- Better shock mounting of the hard disk
